Periodic Inspection of Ofu Harbor Breakwater, American Samoa

Armor Unit Monitoring for Period 1996-2002

Robert R. Bottin, Jr., and Daniel T. Meyers

January 2003

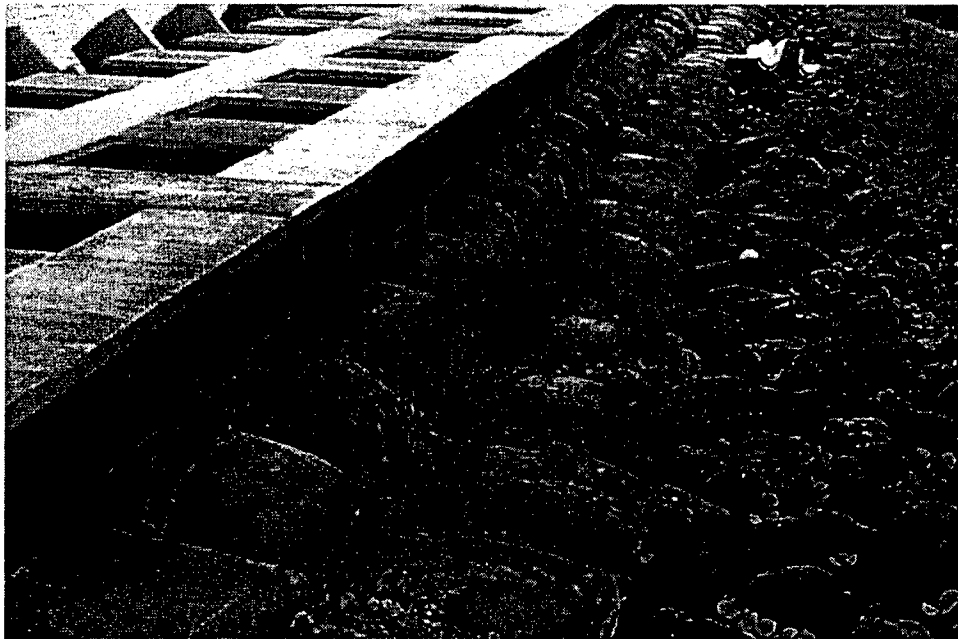
Figure 8. 2,270-kg (2.5-ton) high-strength concrete units used on harbor side of structure

In addition to the “Swiss cheese block” underlayer unit, both 2,270-kg and 510-kg (2.5-ton and 1,125-lb) concrete units were formed by pumping high-strength, fine-aggregate concrete into geotextile fabric bags. The 2,270-kg (2.5-ton) units were used as a rib cap underlayer and were placed along the land-fill on the harbor side of the structure between stas 1+75 and 4+00 (Figure 8). These units measured approximately $1.4 \times 0.9 \times 0.8$ m ($4.5 \times 3.0 \times 2.5$ ft) in size. The 510-kg (1,125-lb) concrete units were used as an underlayer for the 2,270-kg (2.5-ton) units. They also were used as an underlayer for the tribars around the breakwater head since the 1,635-kg (1.8-ton) “Swiss cheese blocks” could not be placed in this area around the relatively tight radius. The dimensions of the 510-kg (1,125-lb) concrete units were about $0.9 \times 0.6 \times 0.3$ m ($3.0 \times 2.0 \times 1.0$ ft). Typical cross sections of the 1994 breakwater construction are presented in Figure 9. An aerial view of the harbor breakwater is shown in Figure 10.

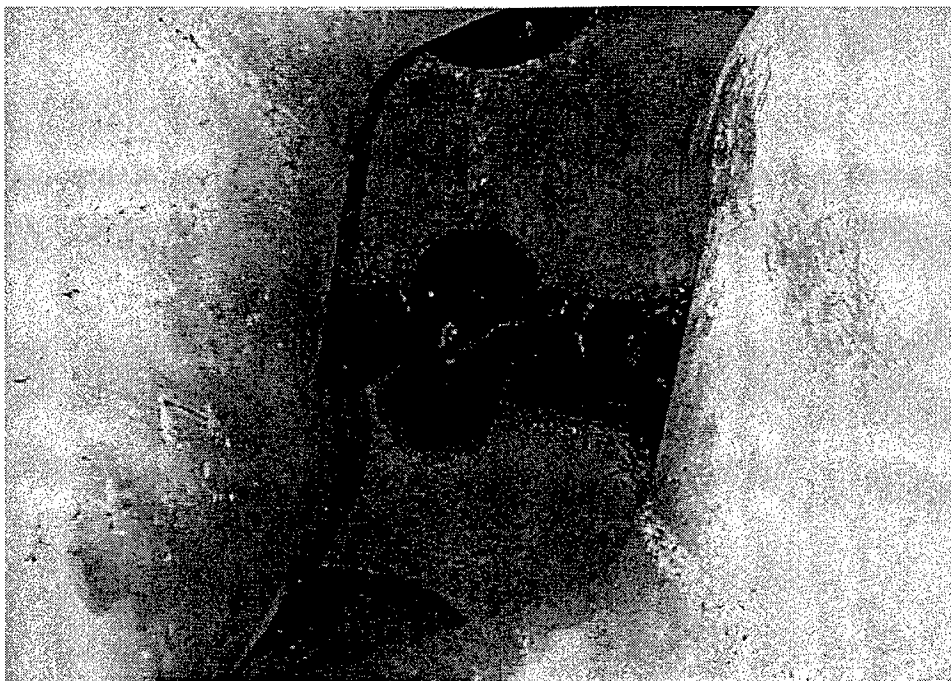
On 22 May 2002, a walking survey of above-water armor units was conducted on the outer 132.6-m (435-ft) portion of the Ofu Harbor breakwater. The survey of the structure revealed no broken tribars. Fifteen sea-side tribars were slightly separated from the rib cap (Figure 11). These separations ranged from 0.64 to 7.62 cm (0.25 to 3 in) and occurred on ribs 2, 12, 13, 14, 16, 20, 22, 25, 26, 32, 39, 42, 66, 67, and 71 (beginning with ribs at the shoreward end). Only one separation was noted during the previous survey at rib 22 (sta 3+07). On the entire sea-side of the structure it also was noted that some of the “Swiss cheese block” underlayer units had separated along the slope between the third and fourth rows (down from the crest). Typical separations ranged from 2.54 to 10.16 cm (1 to 4 in.), and the maximum was about 20.32 cm (8 in.). Some separations were predominantly vertical (Figure 12) while others were predominantly horizontal (Figure 13). Separations of about 2.54 to 10.16 cm (1 to 4 in.), both horizontally and vertically were also noted on “cheese blocks” on the harbor side of the structure. Separations between the “cheese block” underlayer units appeared to be more widespread during this inspection as opposed to the previous one. The geotextile bags had deteriorated and some spalling along the edges of the 510-kg (1,125-lb) high-strength concrete underlayer units was also noted around the head of the structure (Figure 14). These conditions were also noted during the previous inspection. Some slight movement in the breakwater’s underlayer armor units has occurred, but in general, the breakwater appeared to be in excellent condition.

Figure 12. Vertical separation between "Swiss cheese block" underlayer units

0.012 m (0.04 ft) and 0.024 m (0.08 ft) in the horizontal and vertical directions. The current (2002) walking inspection revealed more widespread separations between the "cheese block" concrete underlayer units relative to the 1996 inspection; however, most of the separations were less than 0.09 m (0.3 ft). No armor unit breakage was noted. Overall, the structure appeared to be in excellent condition.

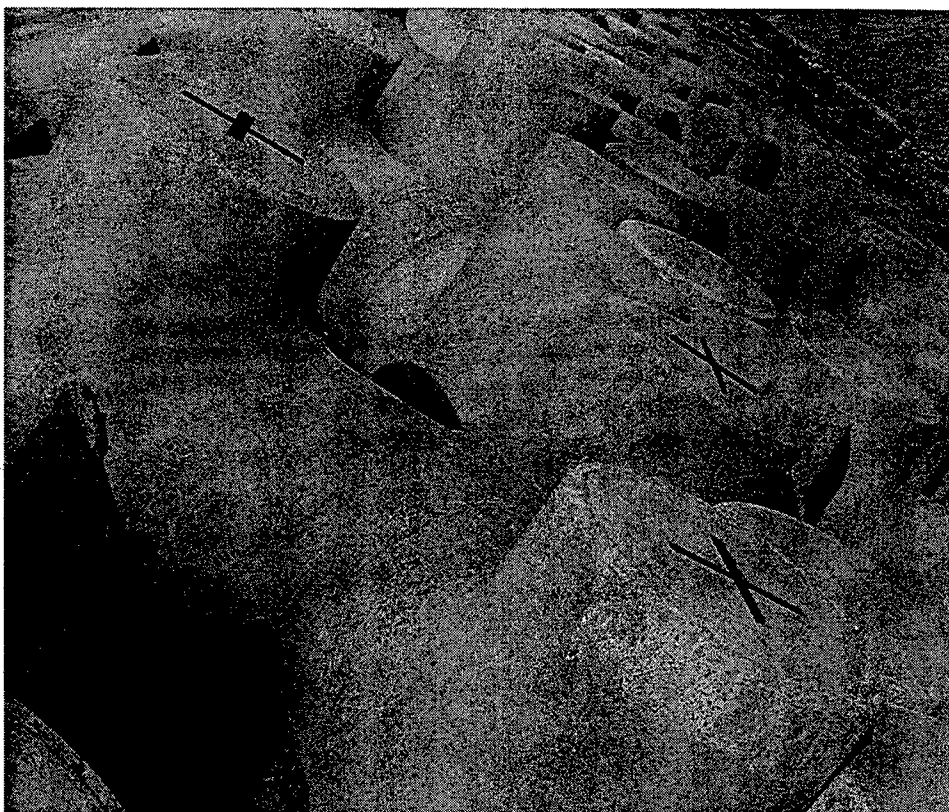
Figure 16. View of a targeted tribar (three targets established)

In addition, targets were re-established on selected concrete armor units. As previously reported (Bottin and Boc 1997), a total of 33 tribars was selected for detailed study. They represent an even distribution throughout the tribar field, and occupy positions ranging from near the waterline to close to the rib cap at the crest of the structure. These armor units (tribars 101-133) were painted with three targets (Figure 16). The target for each tribar is indicated by an A, B, or C. Three targets on an individual tribar allow for very precise measurements depicting individual armor unit movement. Twenty additional tribars (units 19-38) were painted with a single target to serve as photogrammetric control points, as well as to be used to detect armor unit movement during future ground surveys. A 0.64-cm (1/4-in.) hole was drilled at the center of each target to mark the survey points for subsequent surveys. Units were chosen for targeting that had flat surfaces close to horizontal to maximize their visibility in aerial photography and allow for accurate representation of armor unit movement. Locations of the targeted tribars are shown in Figures 17 and 18.
